APPRAISAL REPORT

REF/011.12/2025.PASANGGRAHAN

PASANGGRAHAN ROYAL INN

FRONTSTREET, PHILIPSBURG, SINT MAARTEN

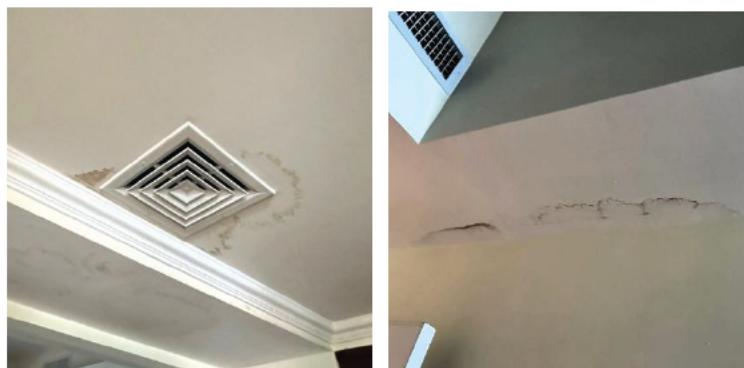
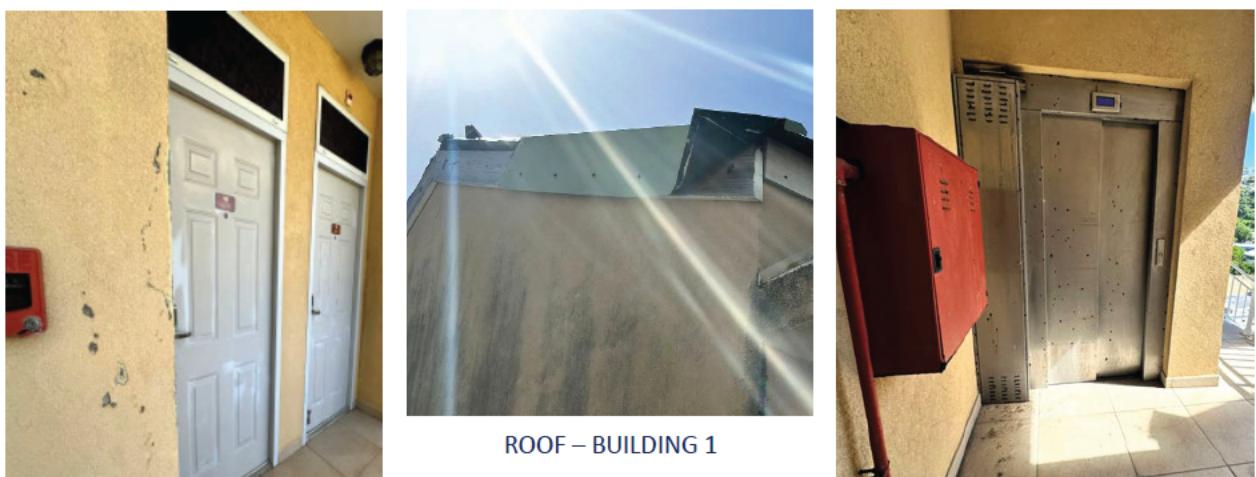
ROOF – BUILDING 1

Subject was partially damaged by hurricane Irma (Sept 2017), after which the structure was partly repaired including a new temporary roof (exposed steel is still evident) and the upper floor "King's Room" yet to be rebuilt. However, the lobby and ground floor are in good shape.

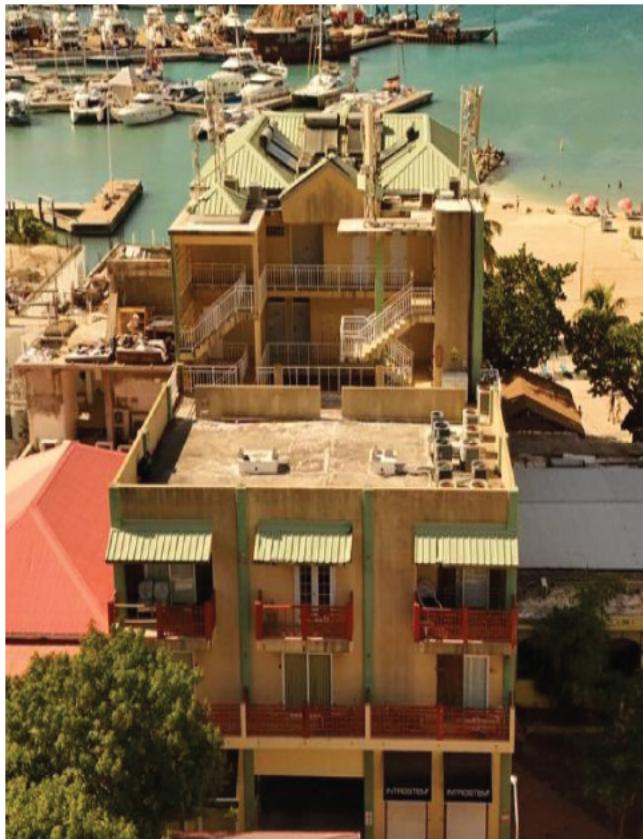
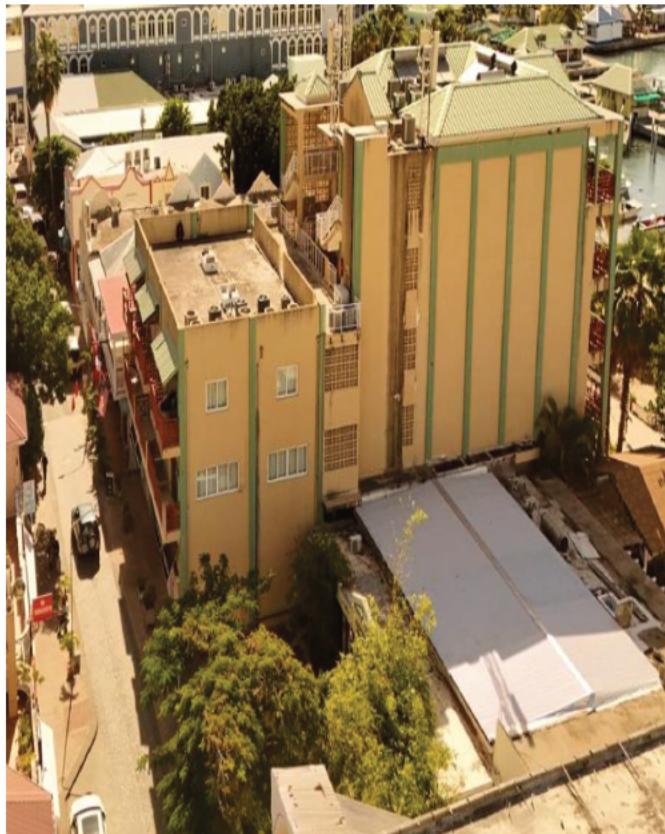
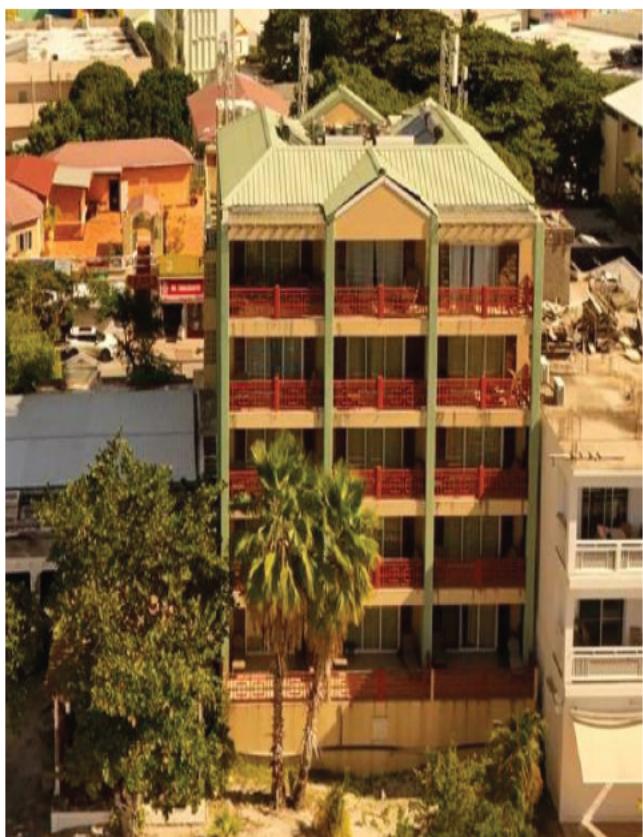
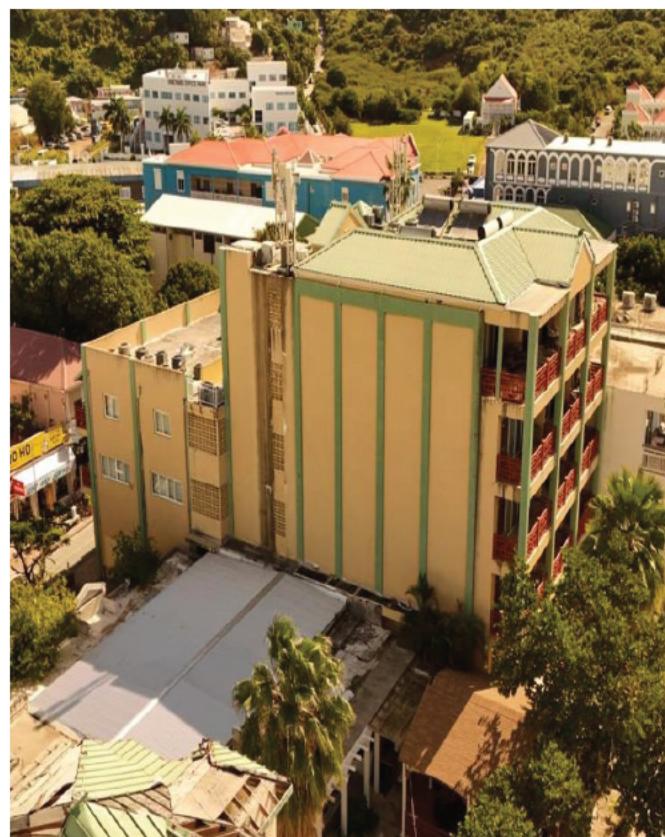
Building #2

This building is used as a hotel property with a total of 23 rooms of which all are habitable, plus two stores at street level. There is minor storm damage extant whereof partial repairs have been effected, mostly cosmetic (eg. ext wall finish and a few lighting fixtures), all caused by impact. At basement level, accessible from Front Street is a parking garage, apparently in good condition.

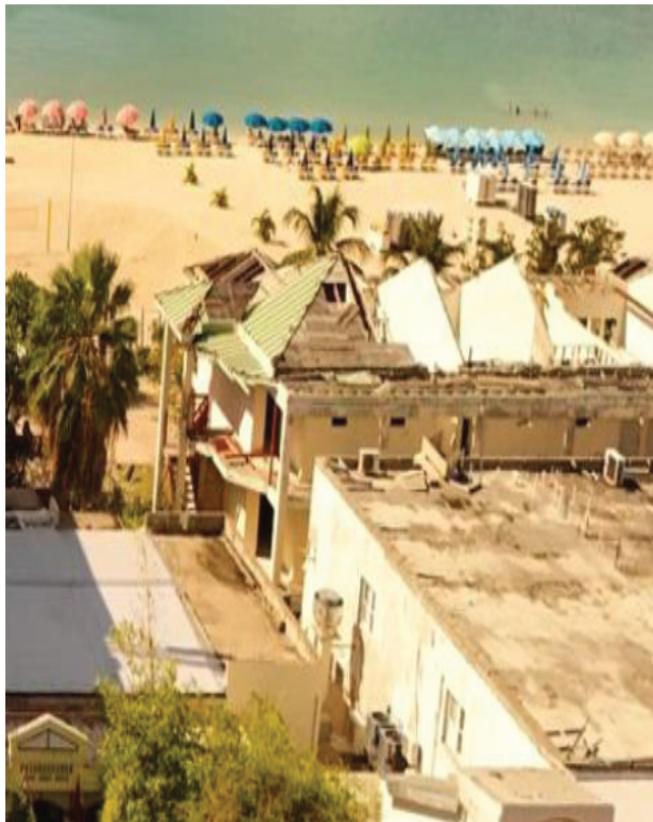
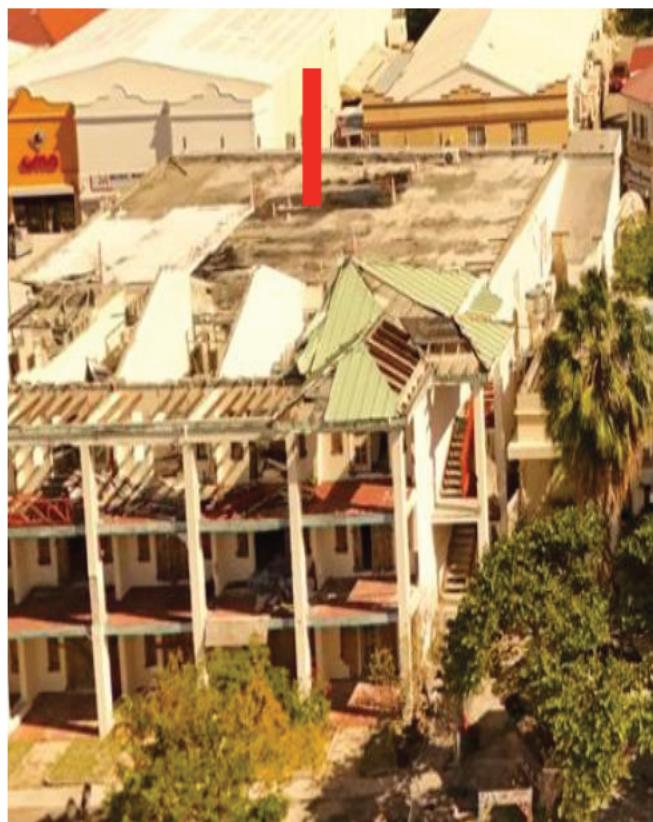
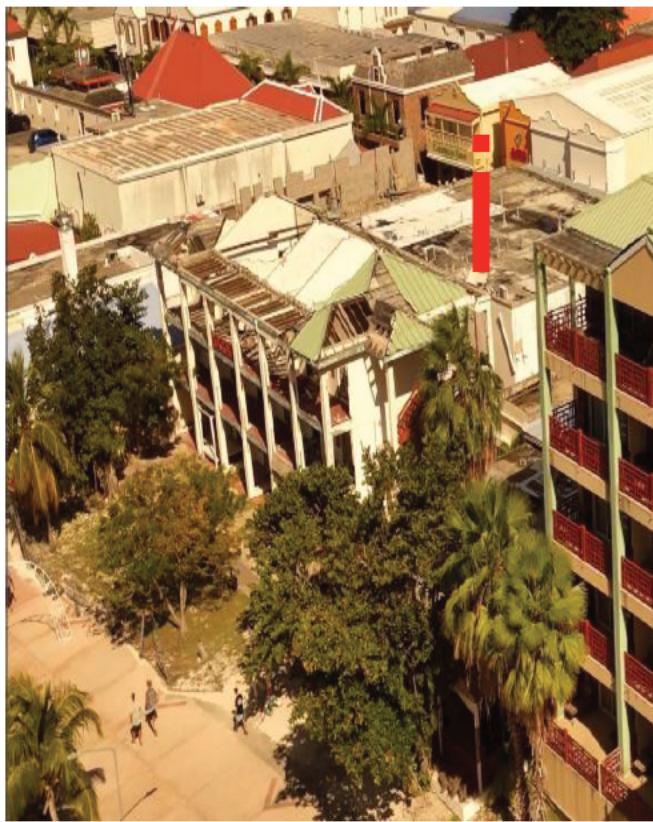
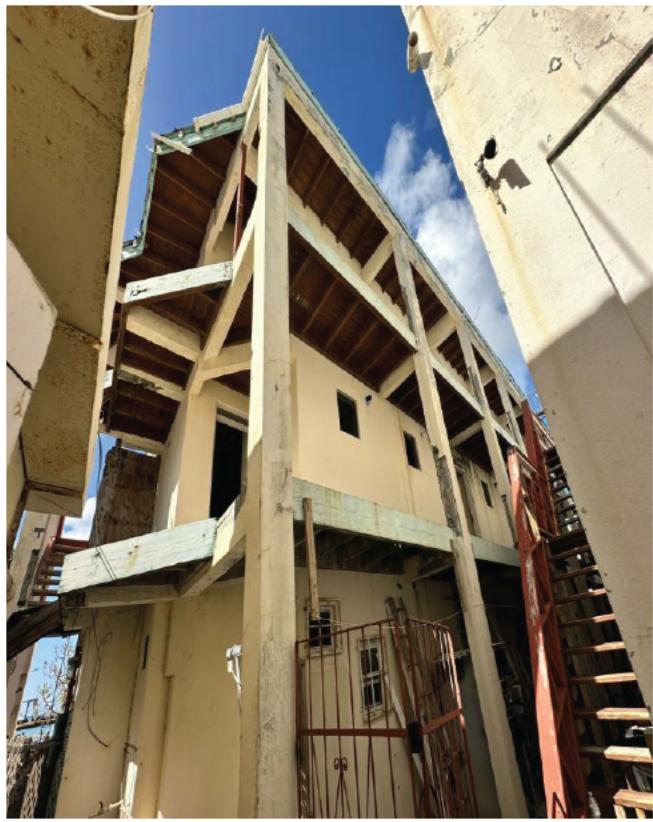
Building #3

This structure was damaged by Hurricane Irma and is now completely unusable. Inspection was limited because of structural damage and lack of access. The roof appears to have been completely removed by the storm and doors and windows for broken or blown in. It is to be noted that the structure has exposed to a saline environment for the past 8 years.

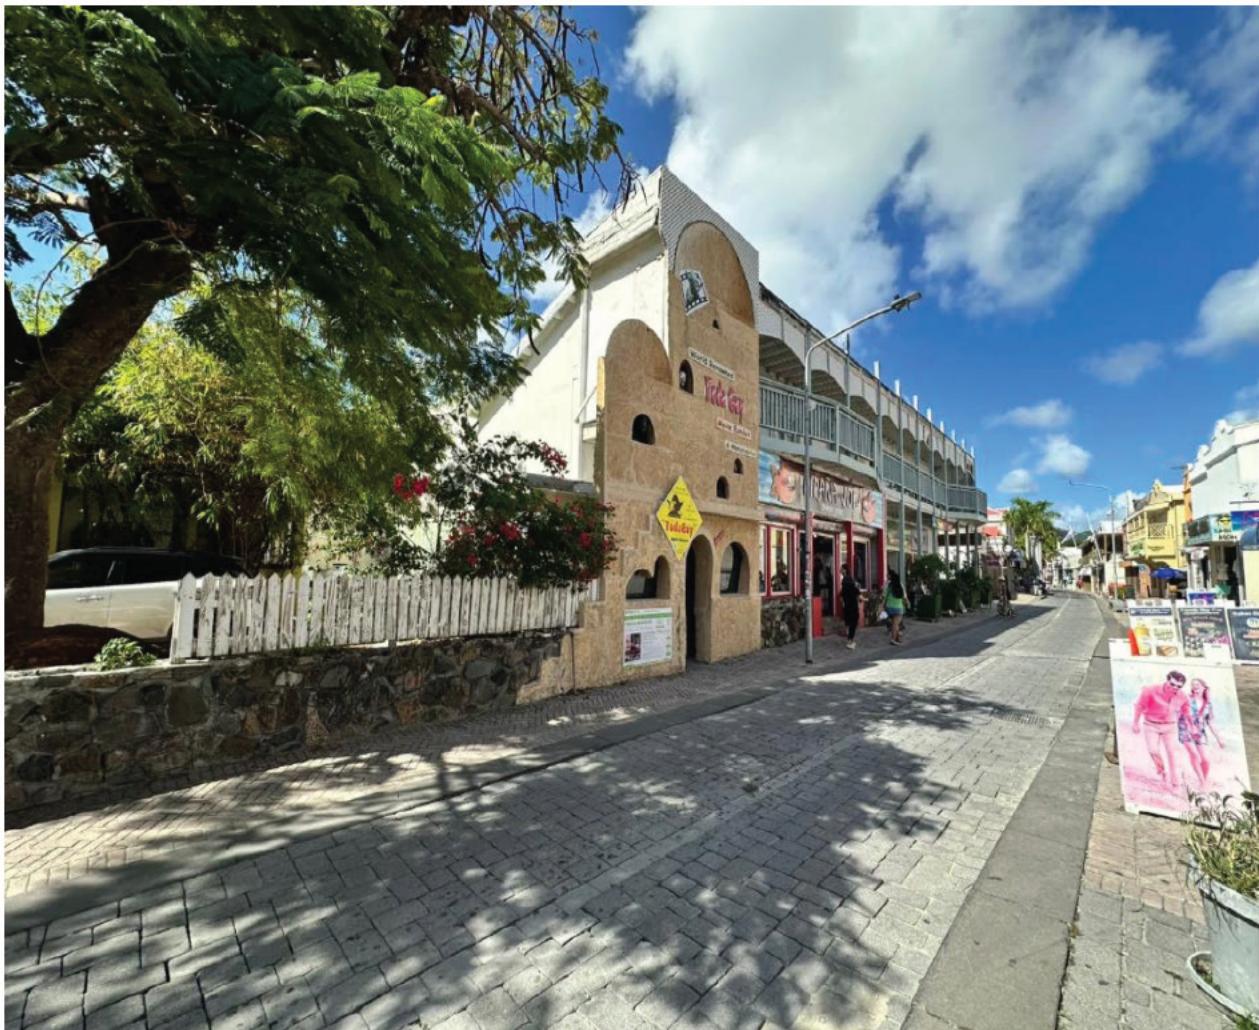
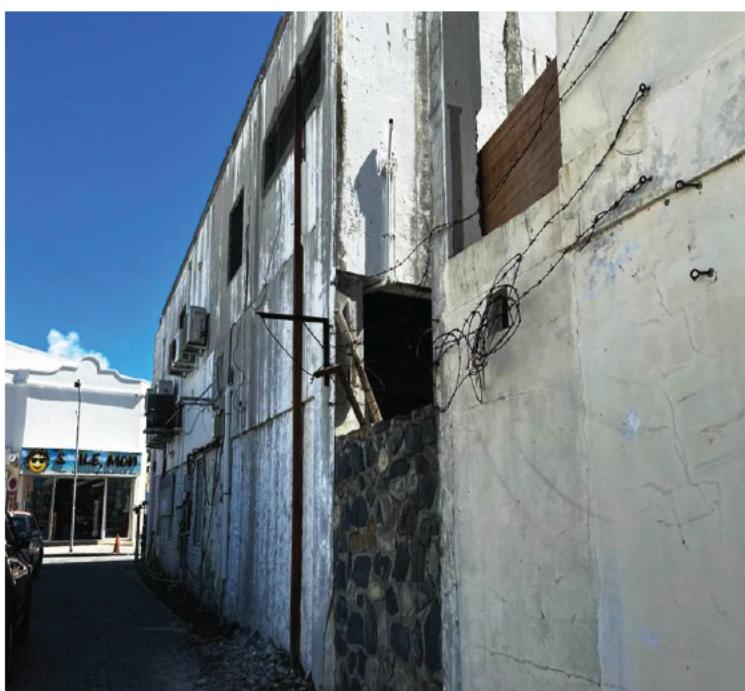
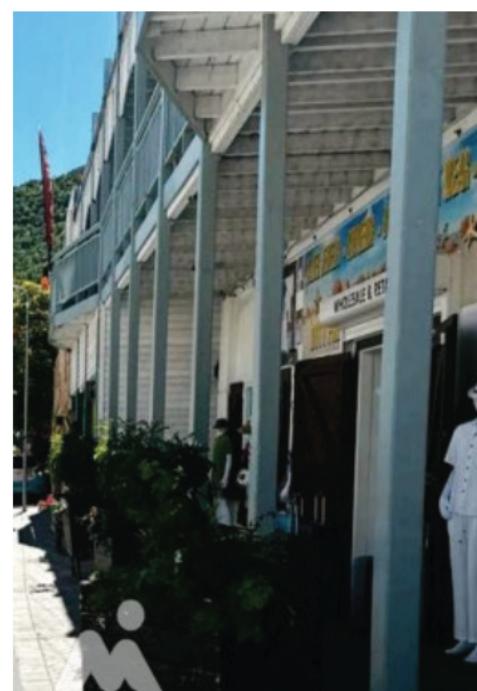
Building #4

This is an all-commercial building with three storefronts on the lower floor, a museum, a conference room and apartment on the upper floor. The building appears to be in reasonable shape although with some considerable deferred maintenance, though apparently fully habitable.
