APPRAISAL REPORT

REF/011.12/2025.PASANGGRAHAN

PASANGGRAHAN ROYAL INN

FRONTSTREET, PHILIPSBURG, SINT MAARTEN

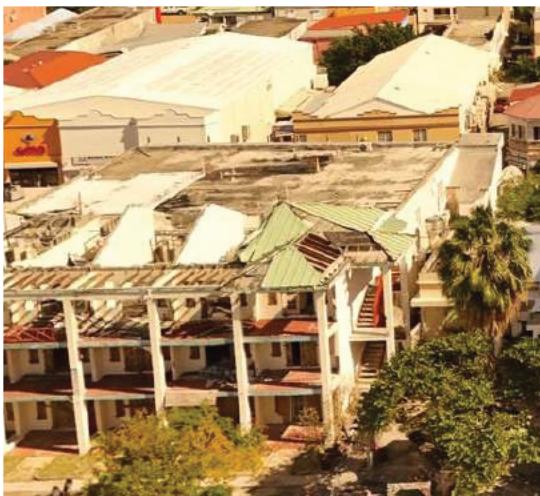
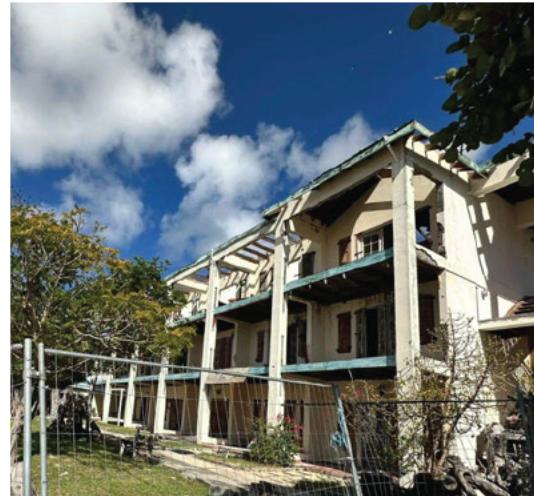
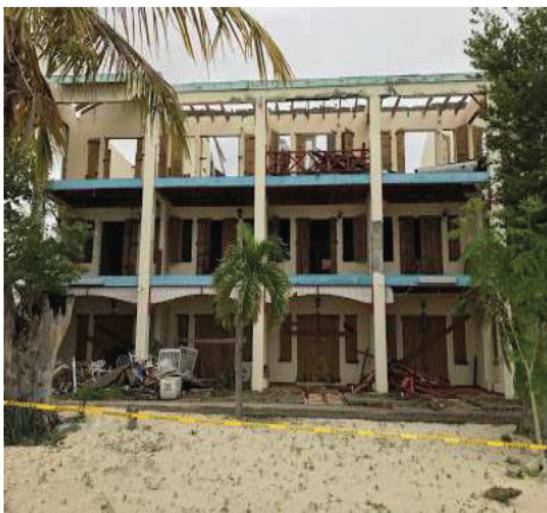
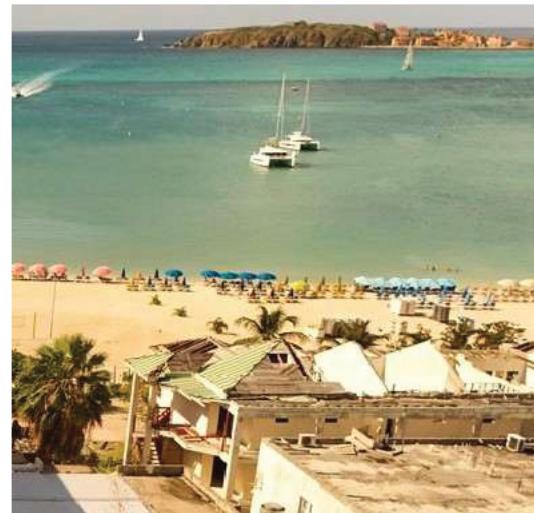
BUILDING #3

A 3-storey building is located at the SW of the property and pre-Irma accommodated 18 identical beach front rooms. Currently this building is not in use, uninhabitable due to considerable damage during the 2017 hurricanes. Estimated areas below:

Estimated age of existing building (yrs.)	44	Estimated remaining life of building (yrs.)	0
-------------------------------------------	----	---------------------------------------------	---

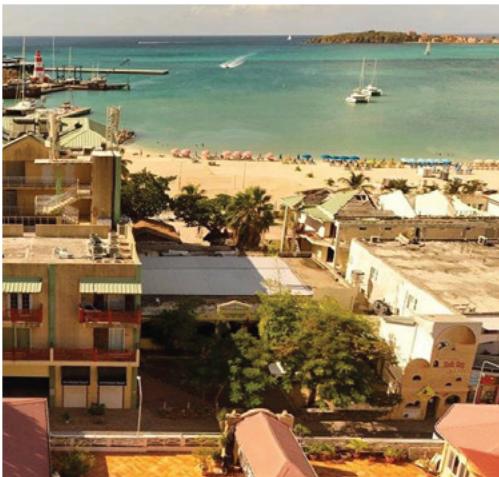
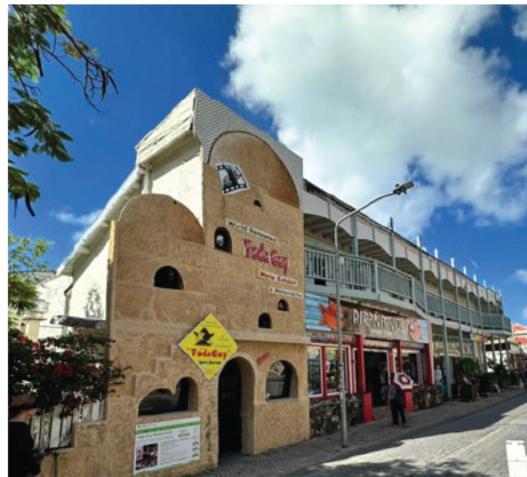
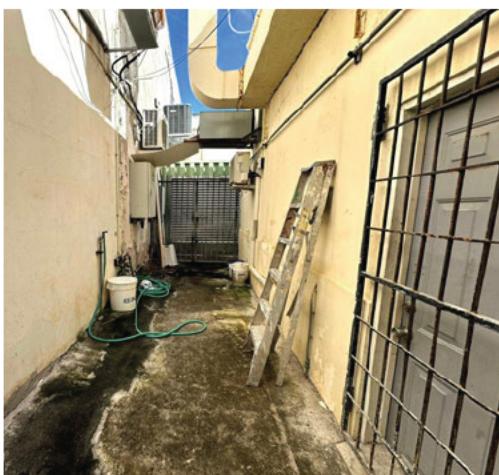
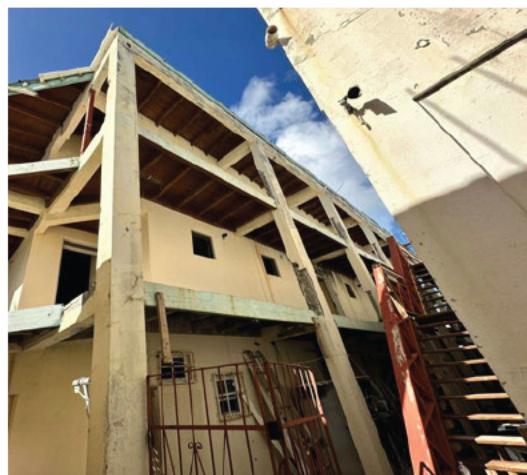
BUILDING #4

This is an all-commercial building with three storefronts on the lower floor, a museum, a conference room and apartment on the upper floor. The building appears to be in reasonable shape although with some considerable deferred maintenance, though apparently fully habitable.

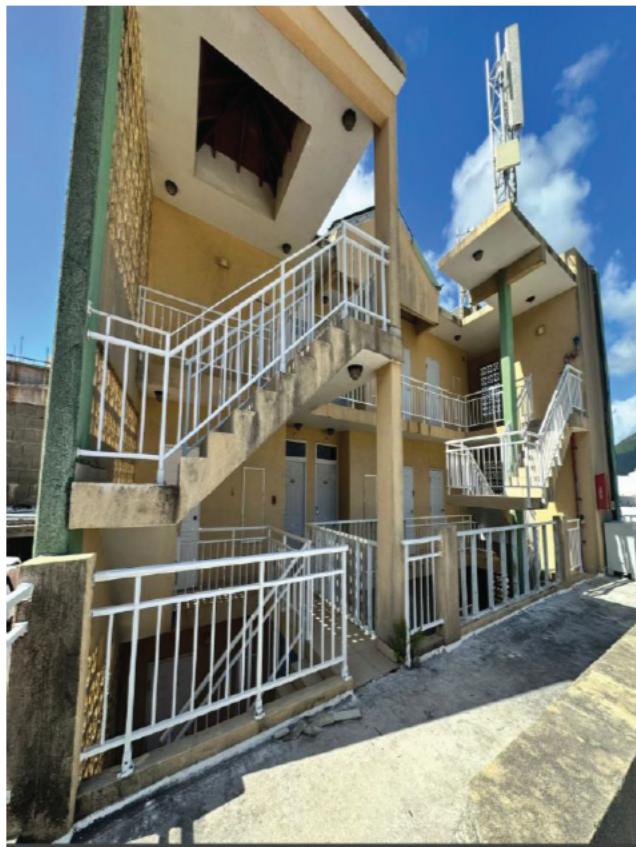
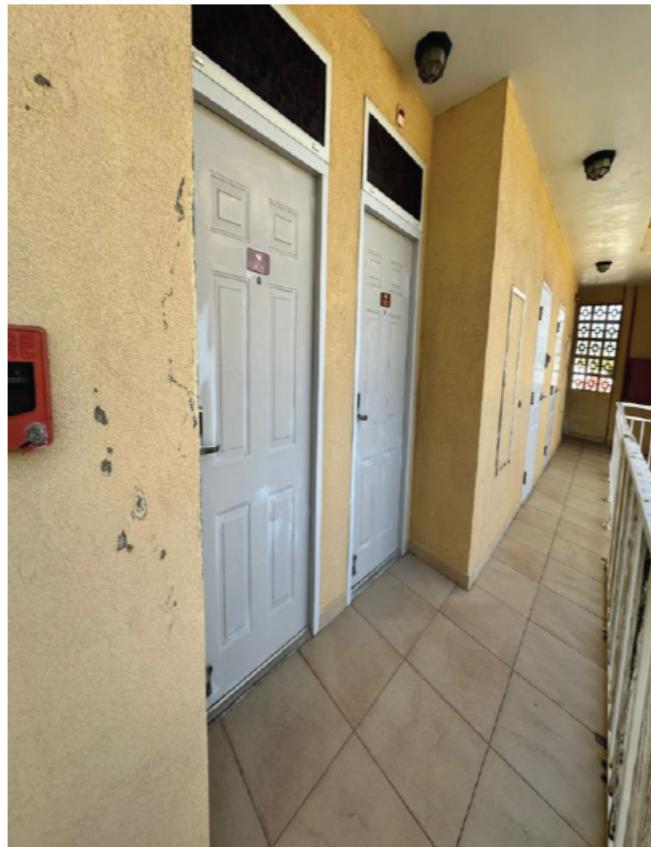
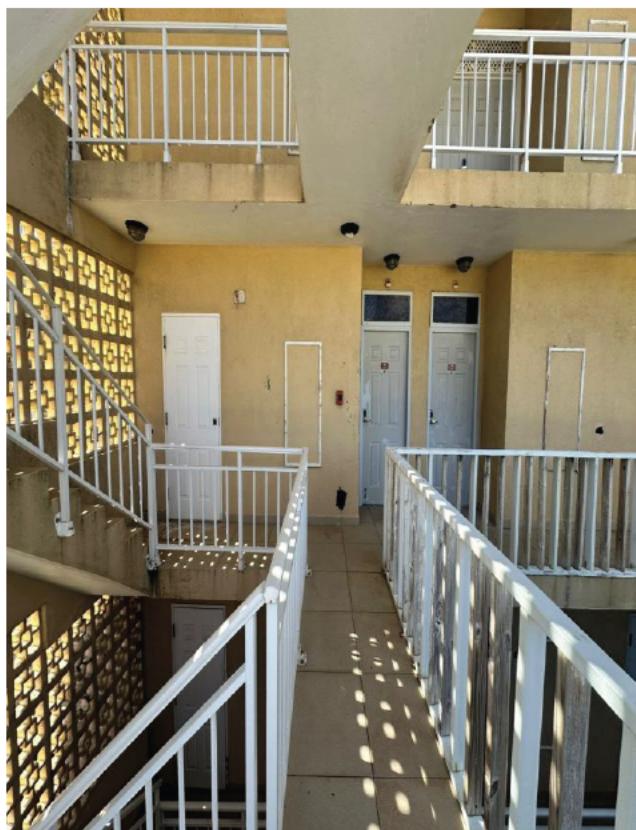
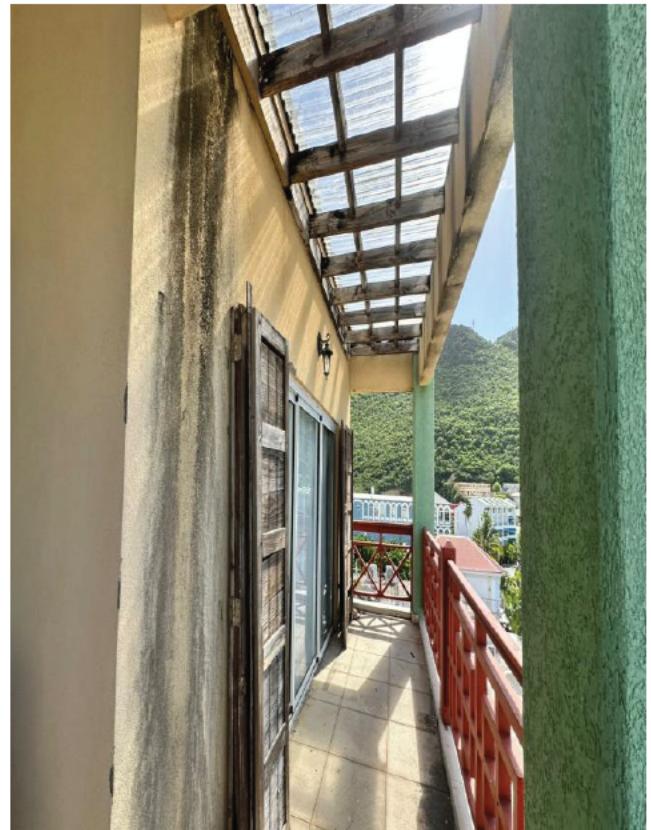
Building #2-Exterior

This building is used as a hotel property with a total of 23 rooms of which all are habitable, plus two stores at street level. There is minor storm damage extant whereof partial repairs have been effected, mostly cosmetic (eg. ext wall finish and a few lighting fixtures), all caused by impact. At basement level, accessible from Front Street is a parking garage, apparently in good condition.
